DENEY RAPORU

TEST REPORT

RFTR22081

Numunenin adı ve tarifi : Single Leaf Timber Doors "AK-03 & AK-02"
Name and identity of test sample

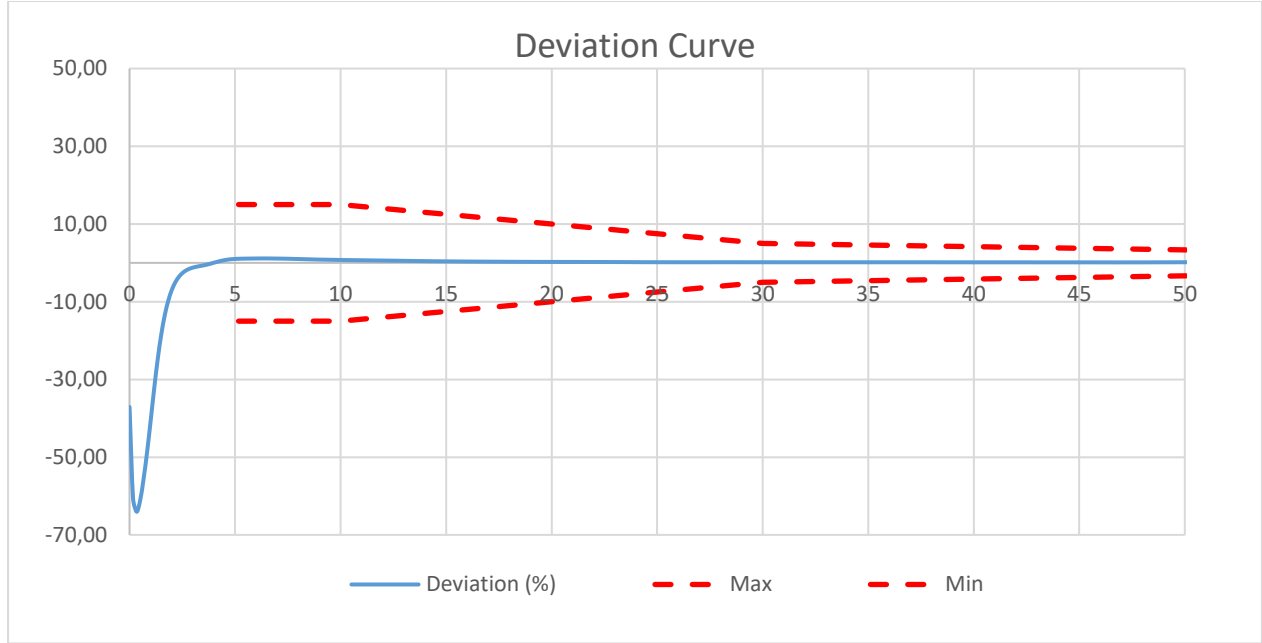
Figure A2: Deviation of furnace temperatures.

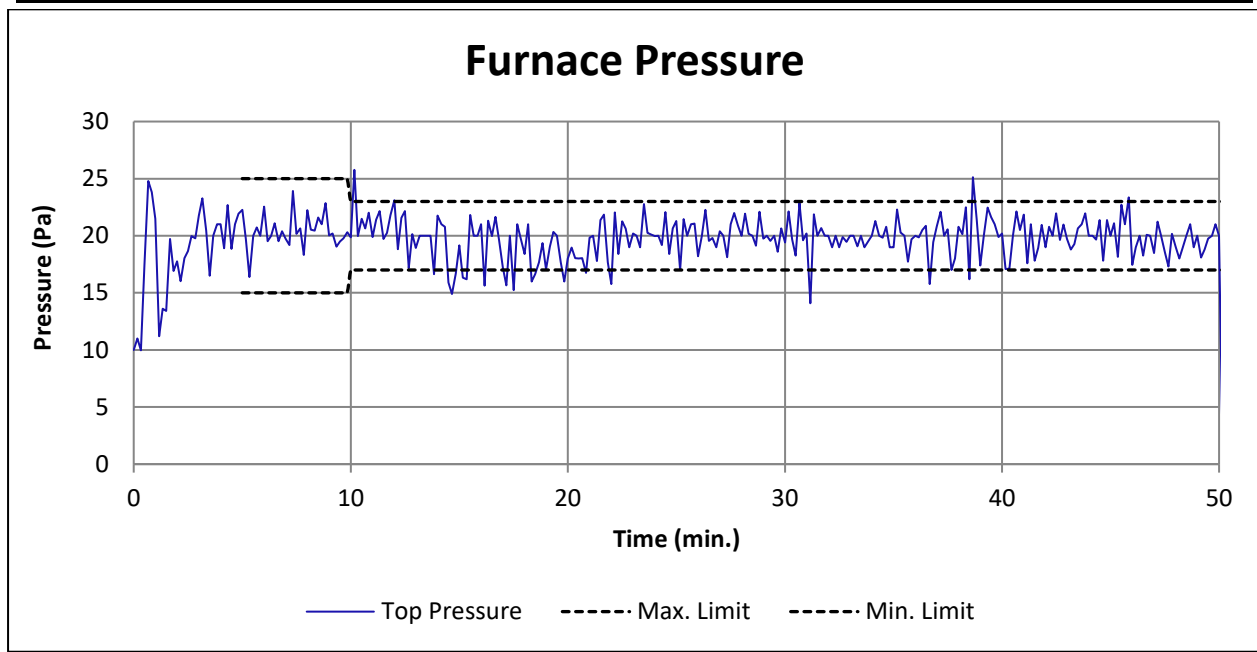
Figure A3: Pressure in the furnace

**Short-term deviations and peaks in furnace pressure were caused by deformations on the specimen and variations in ambient conditions of the laboratory.*

The target overpressure in the furnace was 0 Pa at 500 mm above floor level and 20 Pa at the top of the test specimen.

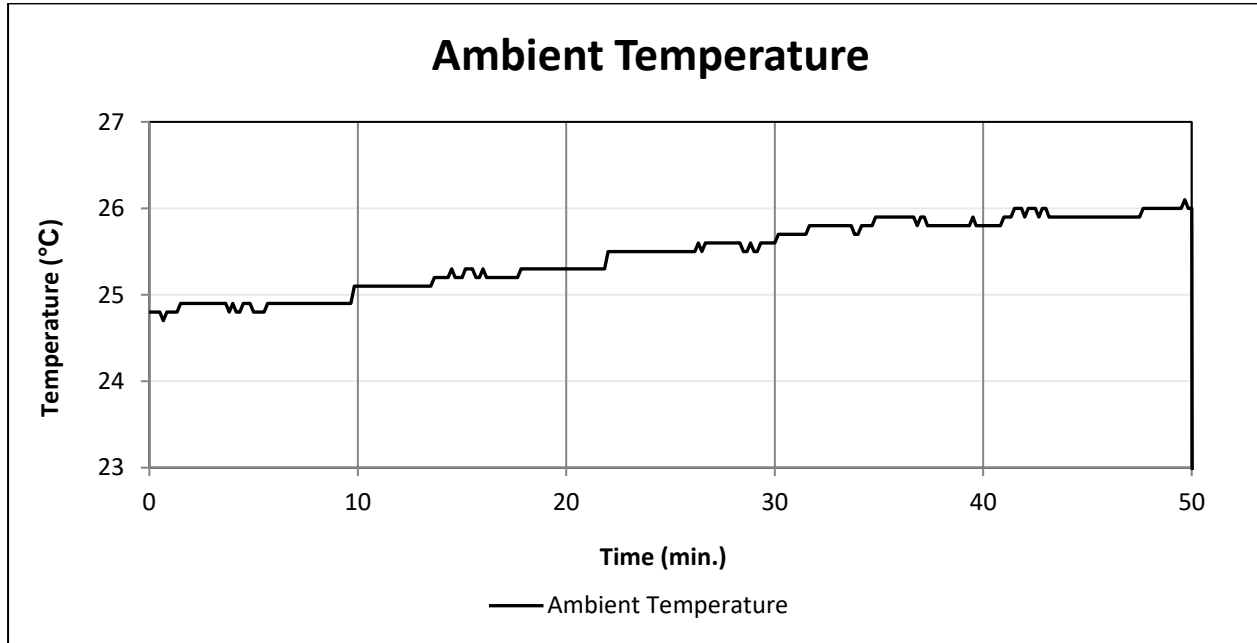
Figure A4: Ambient temperature at laboratory.

During the heating, the temperature in the laboratory complied with the EN 1363-1:2020.

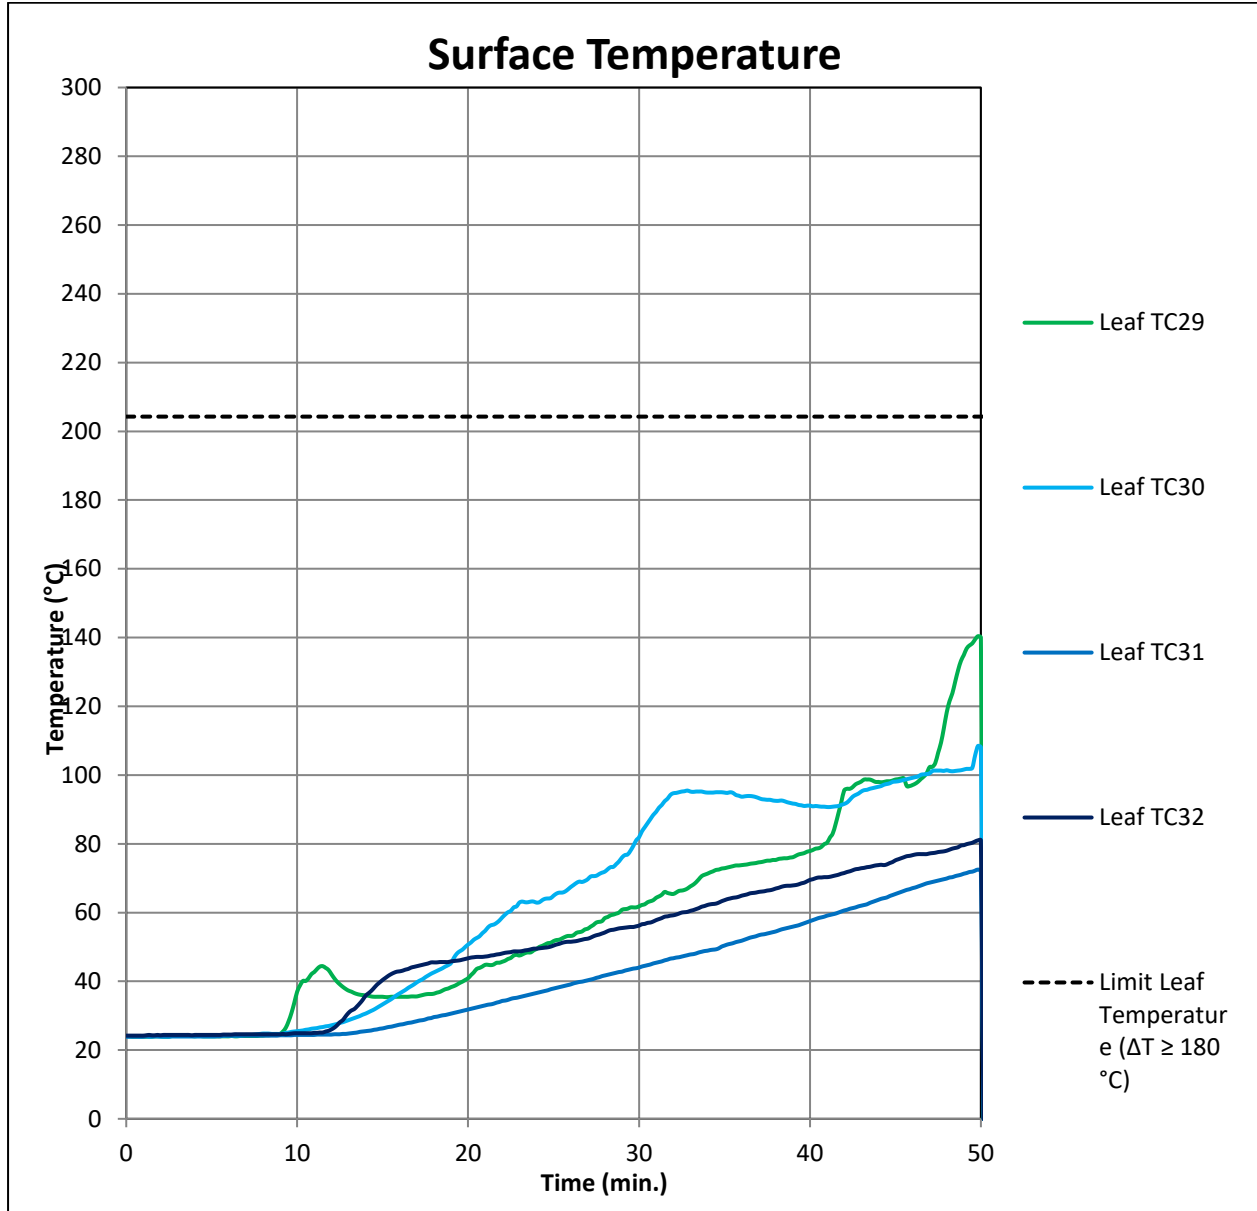
Figure B6: Surface temperatures for the Door Nr.2 (Leaf TC29 – Leaf TC32 and Limit Leaf Temperature).

* Integrity of the Door Nr.2 failed at 49th minutes.

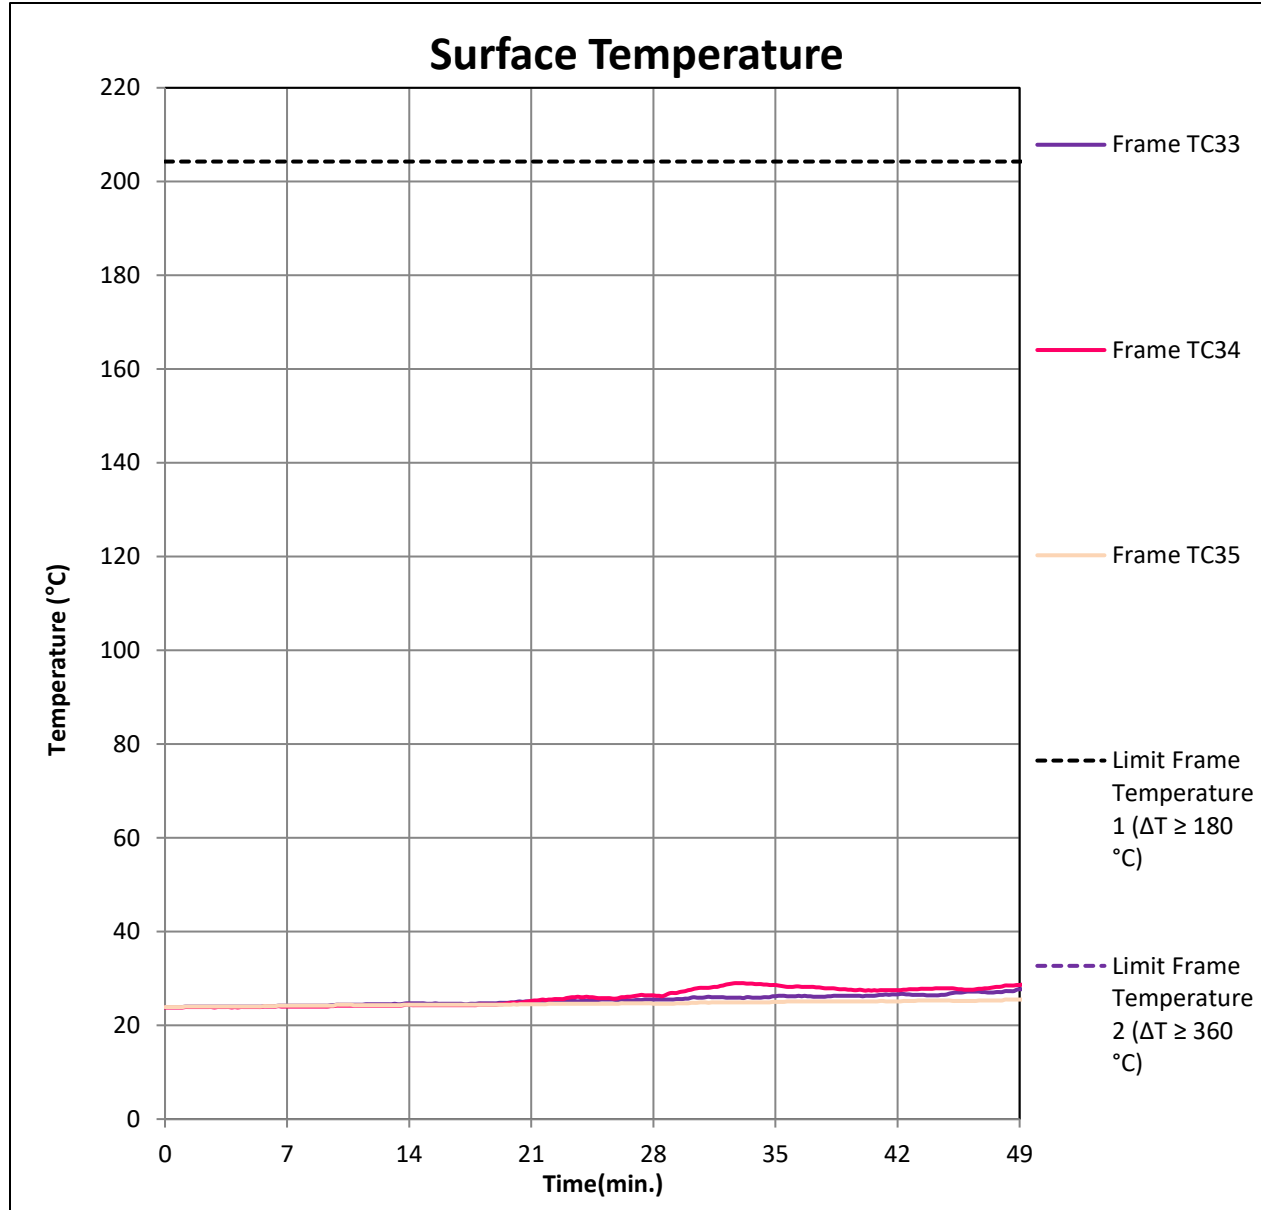
Figure B7: Surface temperatures for the Door Nr.2 (Frame TC33– Frame TC35 and Limit Frame Temperatures).

*Surface TC36 malfunctioned and did not measure.

* Integrity of the Door Nr.2 failed at 49th minutes.

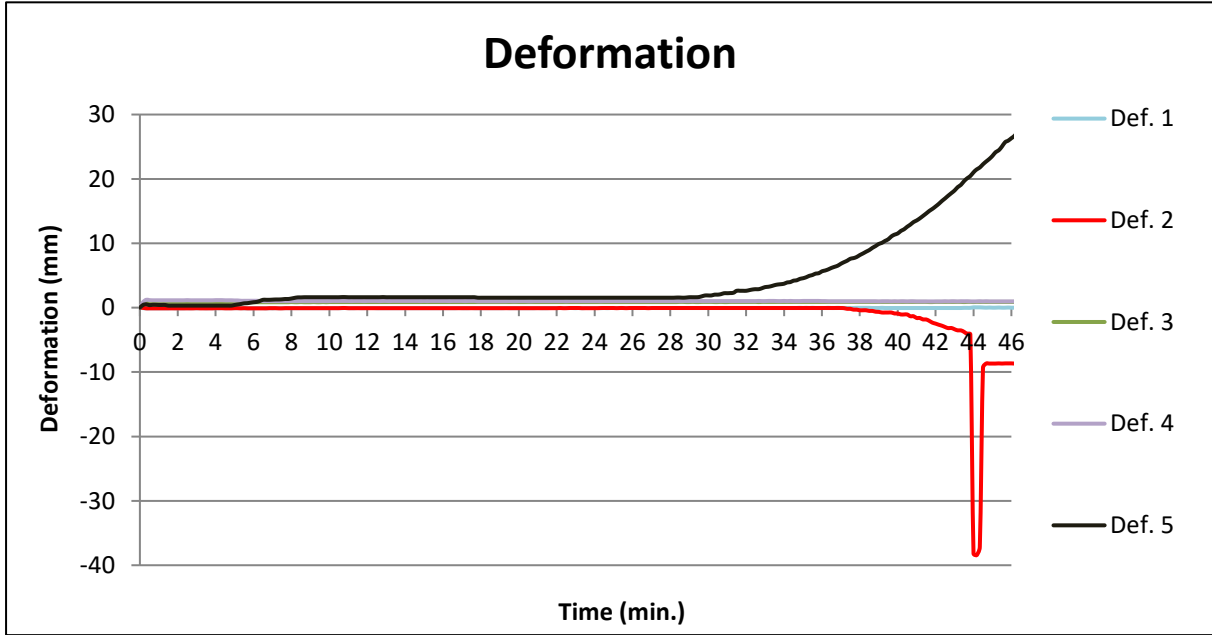
Figure B8: Deformation of the Door Nr.1 (Def. 1 – Def. 5)

*Integrity of the Door Nr.1 failed at 46th minute.

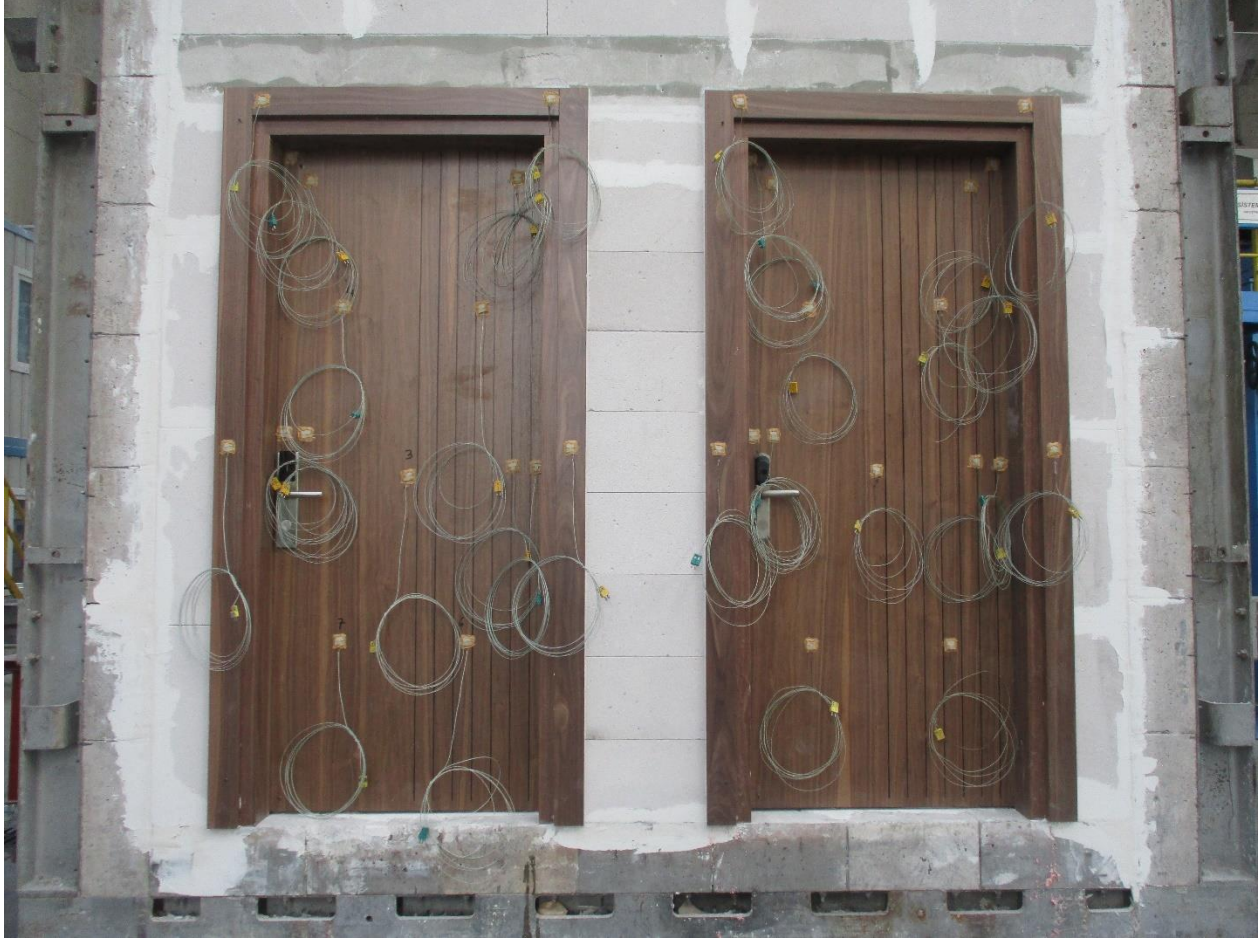
Photo C1: Unexposed side for the test specimens before the test.

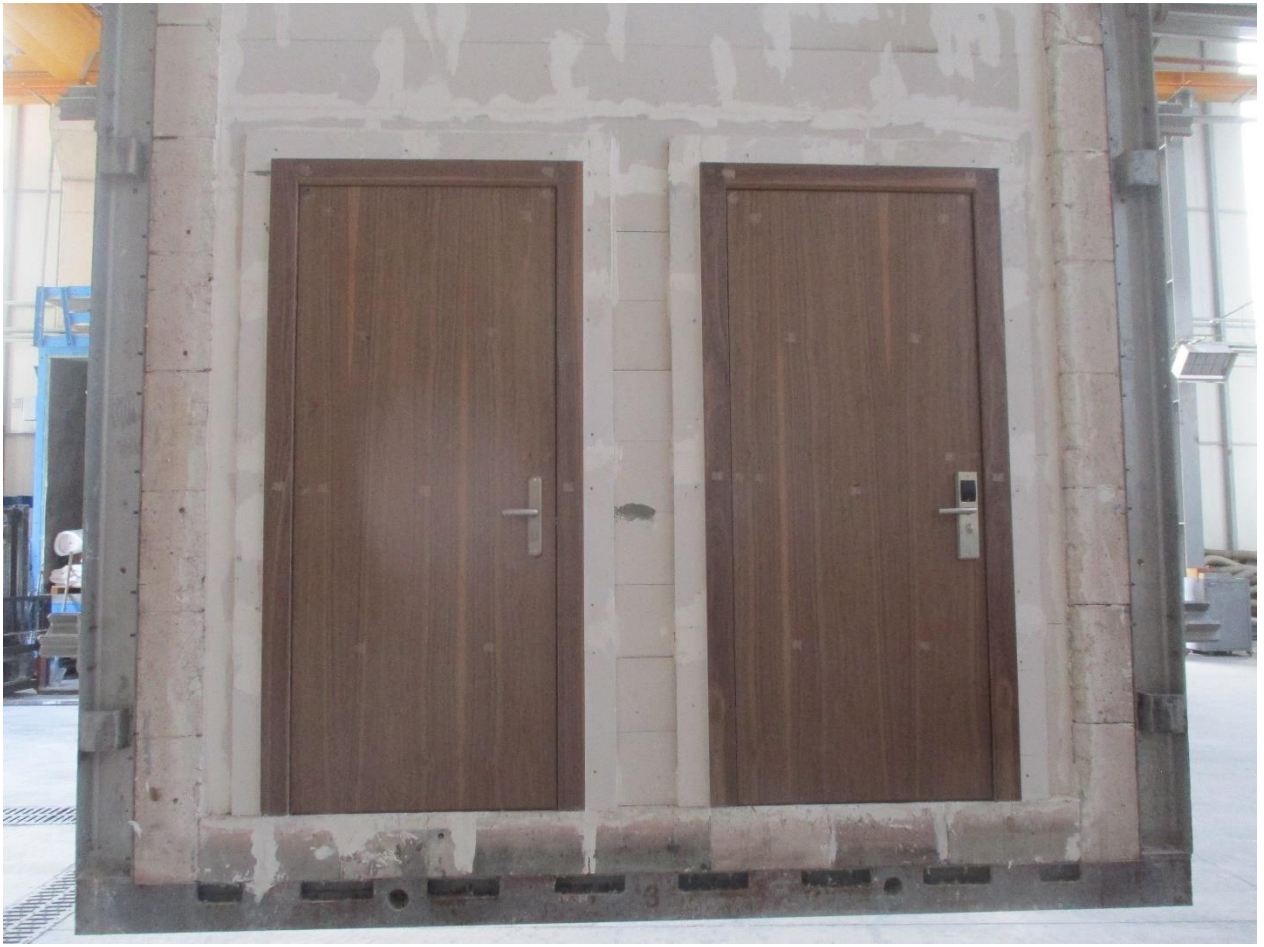
Photo C2: Exposed side for the test specimens before the test.

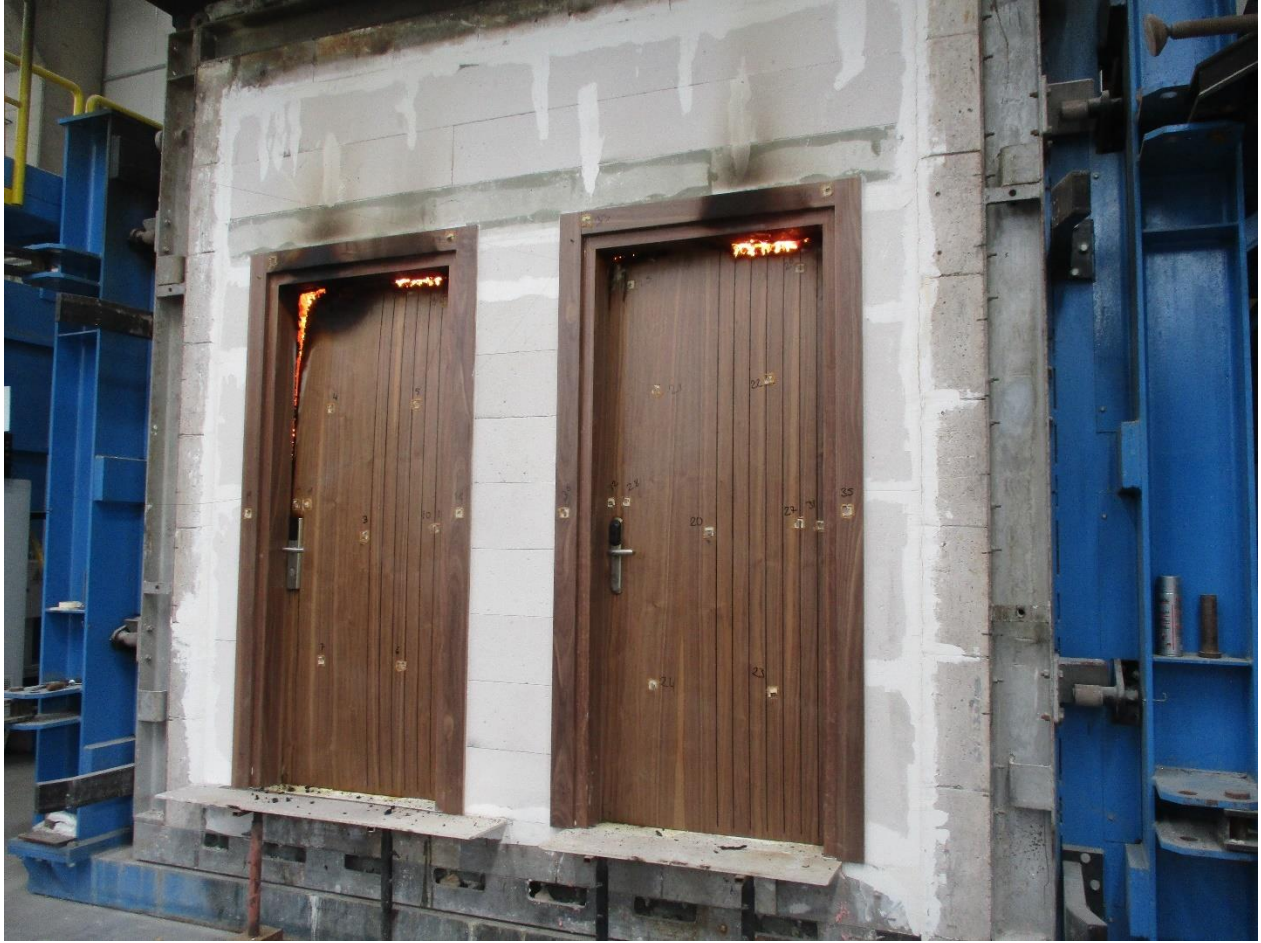
Photo C3: Unexposed side for the test specimens after the test.

0	The heating was started.
3	Smoke release between the leaf and the frame for the doors.
15	Smoke release from the lock area.
30	No considerable change was observed.
35	The opening has occurred between the leaf and the frame at the top right corner of the Door Nr.2. Cotton pad was applied to the opening, no flaming.
44	The opening has occurred between the leaf and the frame at the top left corner of the Door Nr.1. Cotton pad was applied to the opening, no flaming.
45	No considerable change was observed.
46	Sustained flaming between the leaf and the frame at the top left corner, of the Door Nr.1, ff ≥ 10 s. Integrity (E) failed for the Door Nr.1.
49	Temperature increased at the thermocouple Nr.12, ΔT ≥ 180 °C. Insulation (I) failed for the Door Nr.2.
49	Sustained flaming between the leaf and the frame at the top right corner, of the Door Nr.2, ff ≥ 10 s. Integrity (E) failed for the Door Nr.2.
50	The test was terminated 50 th minutes after consultation with the sponsor.
